# EASTMAN PERFORMANCE FILMS, LLC TEST REPORT

ASTM E283, ASTM E331 AND ASTM E330/E330M TESTING  
ON R20 SR PS9 FILM, FIXED WINDOW

J3555.02-109-44

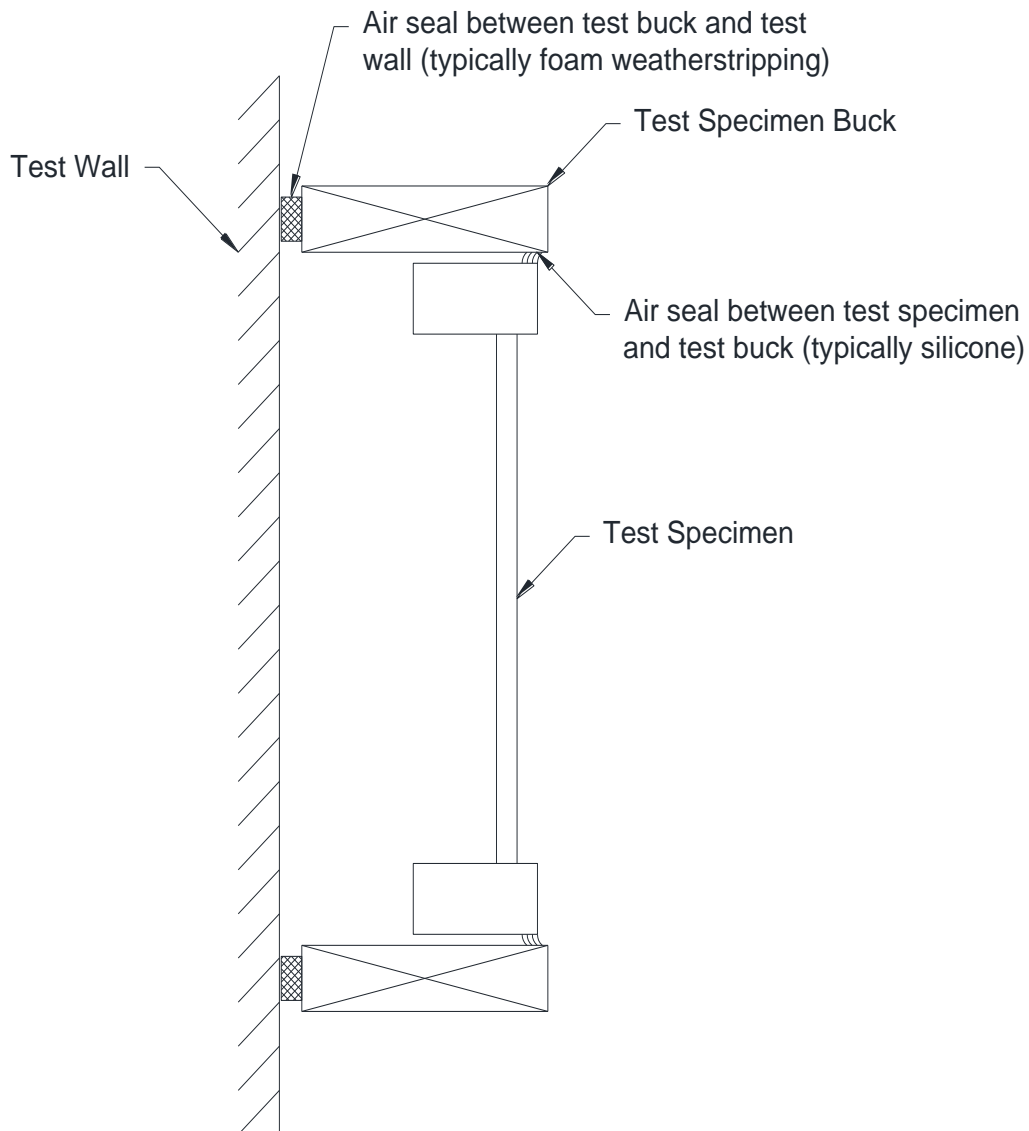
#### LOCATION OF AIR SEAL

The air seal between the test specimen and the test wall is detailed below. The seal is made of foam weatherstripping and is attached to the edge of the test specimen buck. The test specimen buck is placed against the test wall and clamped in place, compressing the weatherstripping and creating a seal.

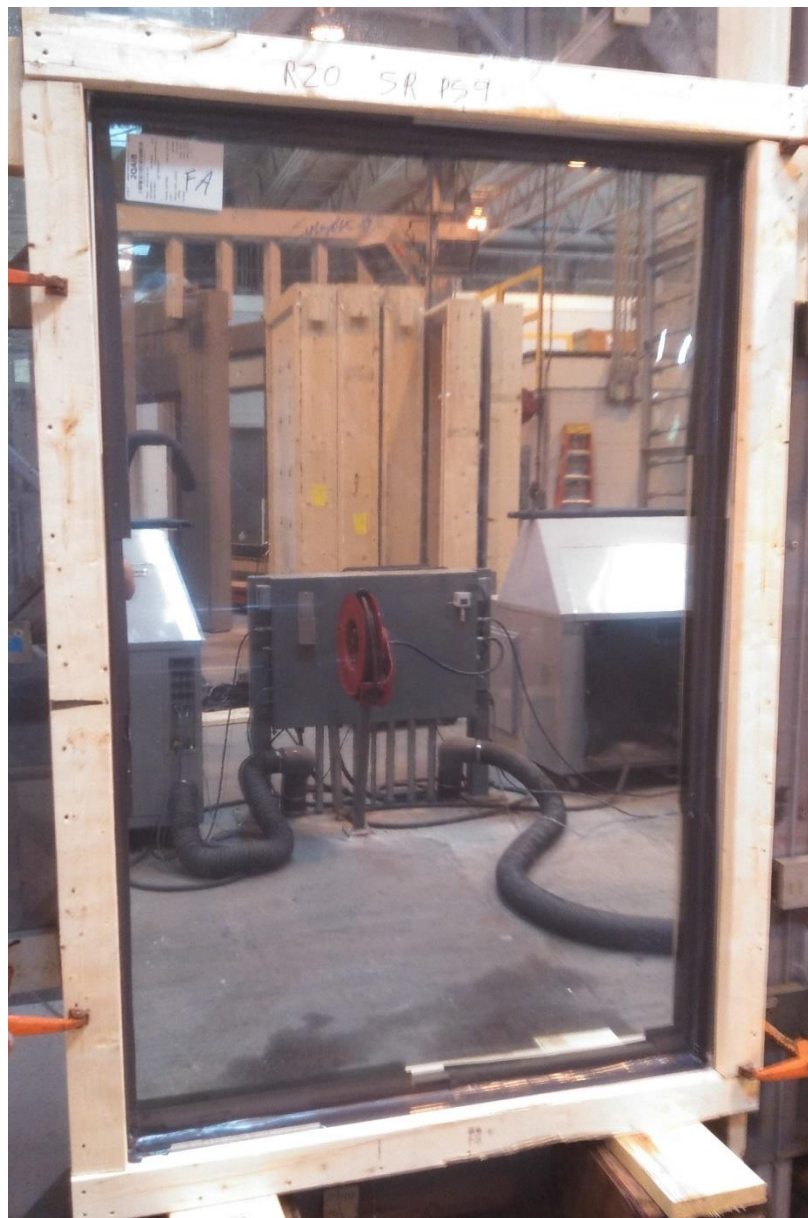
**Photo No. 1**  
**Specimen Prior to Testing**

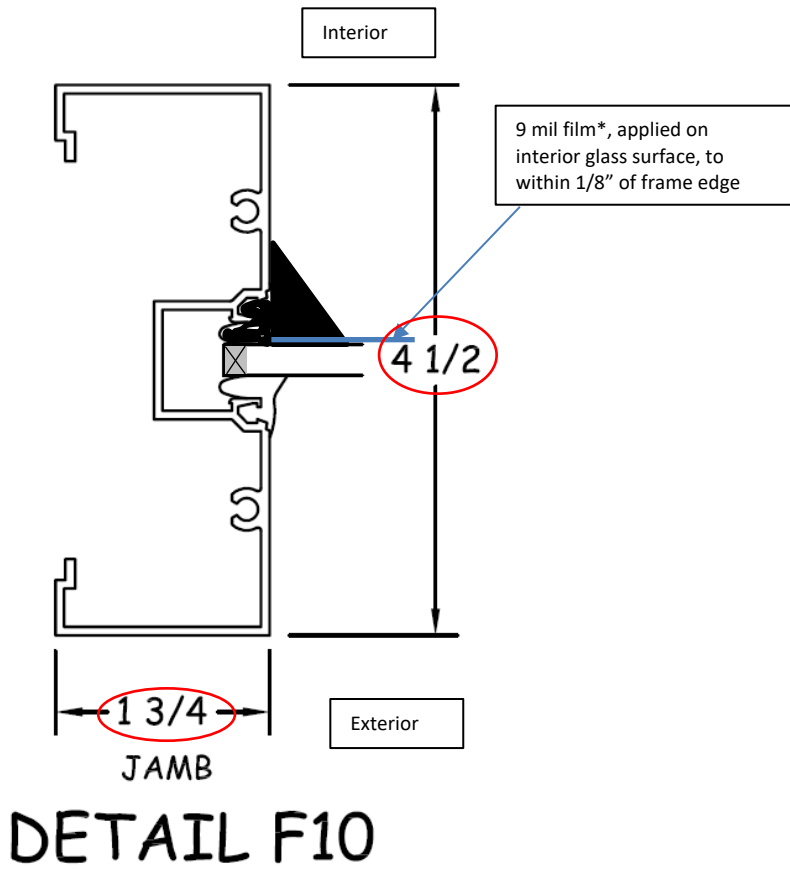
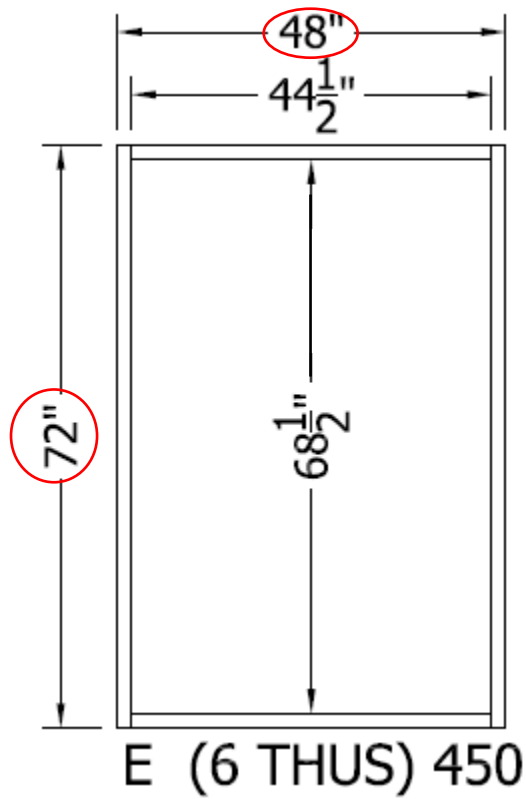
**Kawneer 450 Aluminum Framing**

9 mil film\*, applied on interior glass surface, to within  $\frac{1}{8}$ " of frame edge

Dual Pane Annealed Glass

The test specimen drawings have been reviewed by Intertek B&C and are representative of the test specimen reported herein. Test specimen construction was verified by Intertek B&C per the drawings included in this report. Any deviations are documented herein or on the drawings.
