EASTMAN PERFORMANCE FILMS, LLC

AIRBLAST LOADING TEST REPORT

ASTM F1642/GSA TS01 TESTING ON DR25 SR PS9 SAFETY AND SECURITY PERFORMANCE FILM
INSTALLED ON A FIXED WINDOW SYSTEM
(SINGLE PANE, ANNEALED, SILICONE GLAZING ATTACHMENT)

J3983.07-119-12 R0

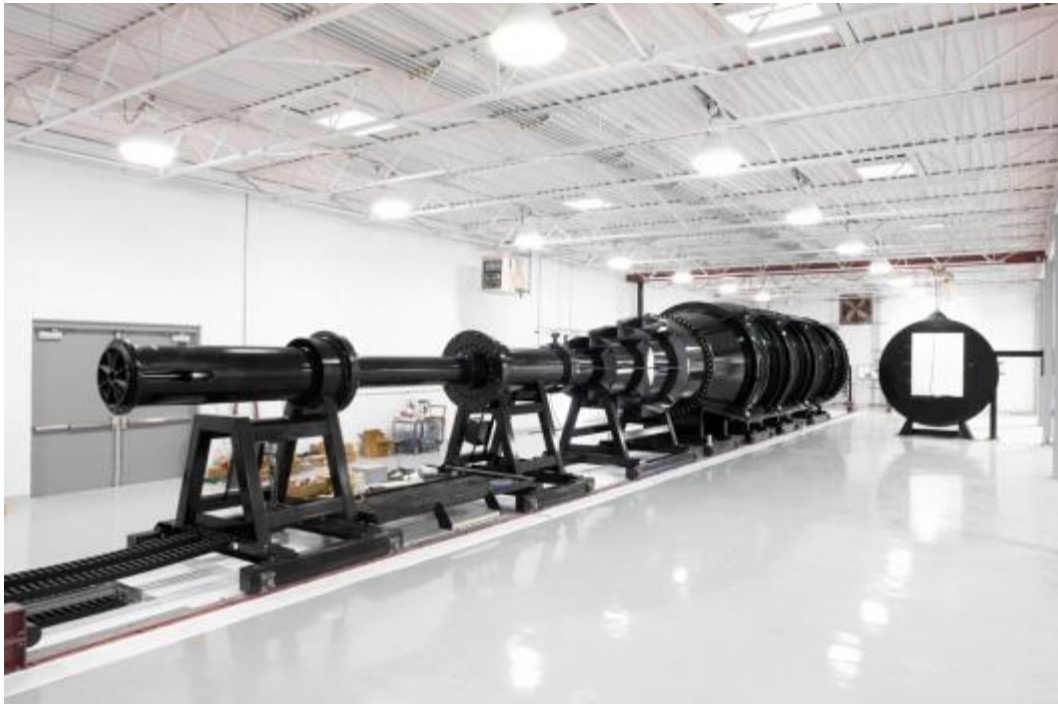
Figure #1
Shock Tube and Test Facility

Intertek B&C's shock tube is housed in a 10,000 square foot state-of-the-art test facility located in York, Pennsylvania. A photograph of the shock tube is provided in Figure #1.

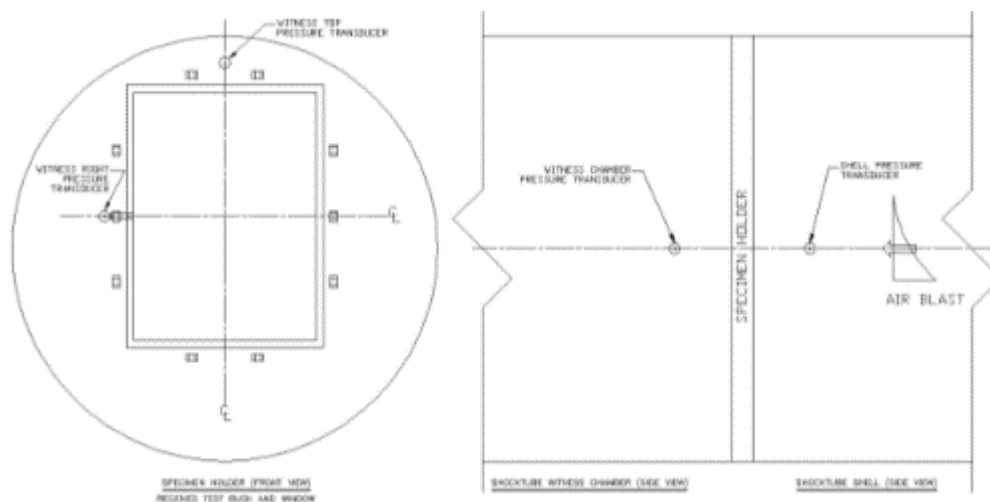
Figure #2
Pressure Sensor Locations

In accordance with ASTM F1642 and GSA TS01, four reflective pressure transducers were utilized for data acquisition at a 1MHz sample rate. Two reflective pressure transducers were located on the specimen holder at the top and right side (when viewed from the interior). A third pressure transducer was located on the shell to the exterior of the specimen, and a fourth was located in the witness chamber, directly to the interior of the specimen holder. A sketch of the specimen holder and corresponding reflective pressure sensor locations is provided in Figure #2.

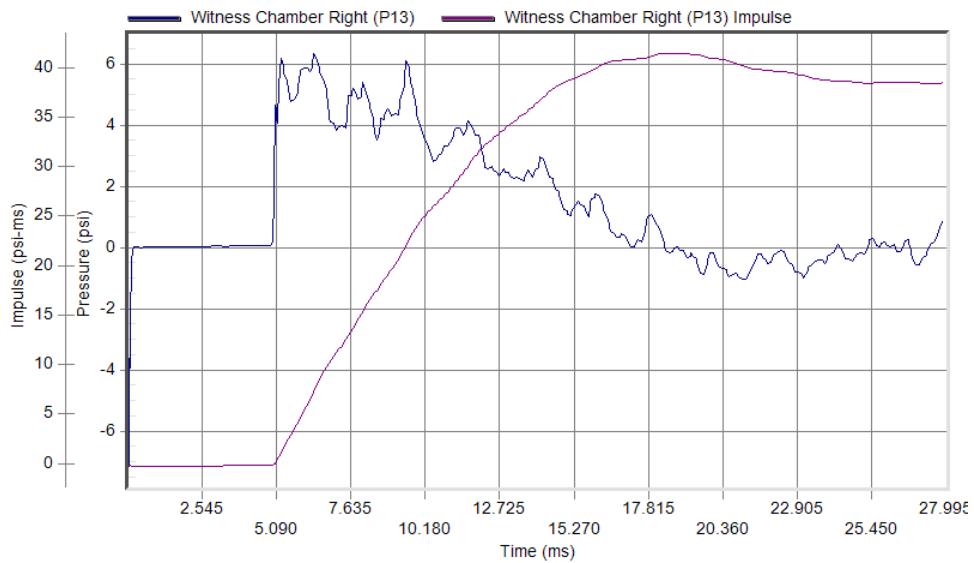
Peak Pressure: 6.35 psi at 6.41 ms
Duration: 10.79 ms

Test Date: 6/24/2019
Test Time: 3:07 pm

DESCRIPTION	RESULTS
Ambient Temperature	86°F
Glazing Temperature	88°F
ASTM Hazard Rating	Very Low Hazard
GSA Performance Condition	3b
PEAK POSITIVE PRESSURE	
Top Pressure	6.17 psi
Right Pressure	6.35 psi
Shell Pressure	6.20 psi
Average Pressure	6.24 psi
Witness Chamber Pressure	0.39 psi
PEAK POSITIVE PHASE DURATION	
Top Duration	12.84 msec
Right Duration	10.79 msec
Shell Duration	13.03 msec
Average Duration	12.22 msec
PEAK POSITIVE PHASE IMPULSE	
Top Impulse	41 psi*msec
Right Impulse	41 psi*msec
Shell Impulse	41 psi*msec
Average Impulse	41 psi*msec
GLAZING RESPONSE	
Exterior Lite	Fractured
Interior Lite	N/A
Glazing Pullout	None
Film Tearing	None
WITNESS CHAMBER RESULTS	
Two perforations found on the witness panel. One fragment was found past the 1M mark, totaling 3.06g.

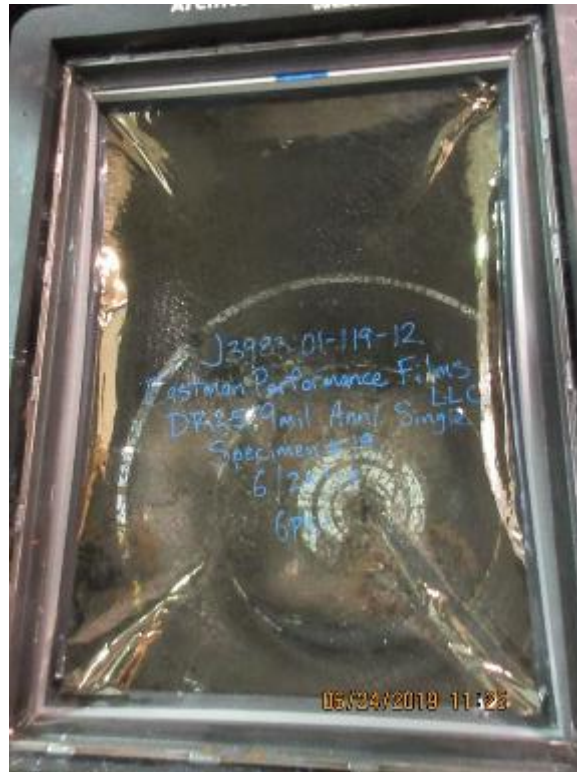
Photo No. 2
Post-test Specimen #1, Interior

DESCRIPTION	RESULTS
Ambient Temperature	82°F
Glazing Temperature	83°F
ASTM Hazard Rating	Very Low Hazard
GSA Performance Condition	3a
PEAK POSITIVE PRESSURE	
Top Pressure	6.15 psi
Right Pressure	6.28 psi
Shell Pressure	6.01 psi
Average Pressure	6.15 psi
Witness Chamber Pressure	0.36 psi
PEAK POSITIVE PHASE DURATION	
Top Duration	12.50 msec
Right Duration	7.20 msec
Shell Duration	12.26 msec
Average Duration	10.65 msec
PEAK POSITIVE PHASE IMPULSE	
Top Impulse	41 psi*msec
Right Impulse	42 psi*msec
Shell Impulse	41 psi*msec
Average Impulse	41 psi*msec
GLAZING RESPONSE	
Exterior Lite	Fractured
Interior Lite	N/A
Glazing Pullout	None
Film Tearing	None
WITNESS CHAMBER RESULTS	
Five perforations, 8 indents found on the witness panel. Two fragments were found before the 1M mark, totaling 3.24g.

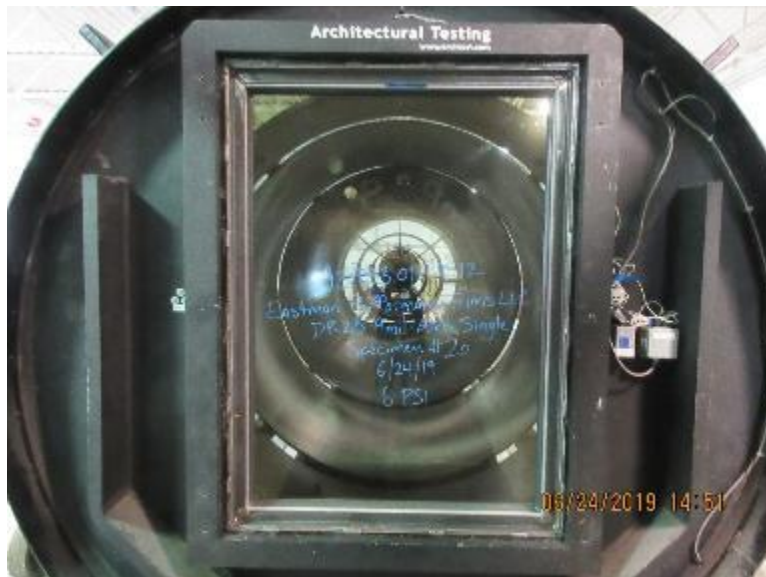
Photo No. 4
Pre-test Specimen #2, Interior

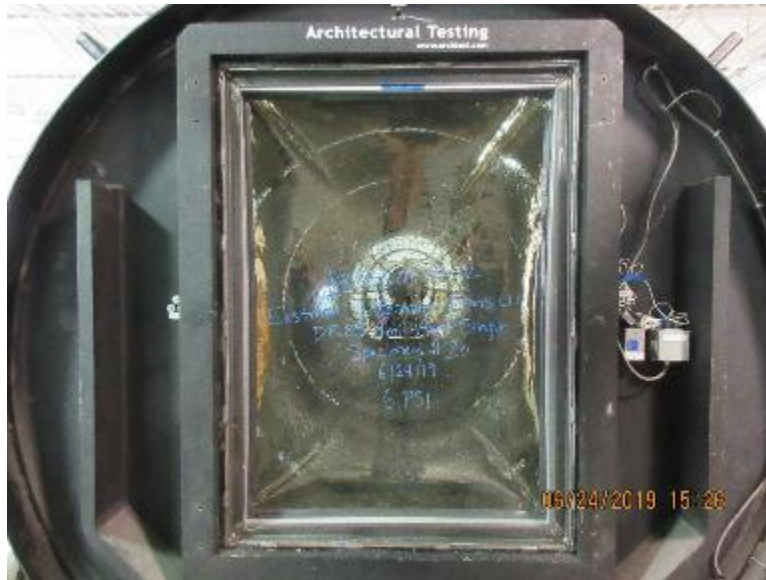
Photo No. 5
Post-test Specimen #2, Interior

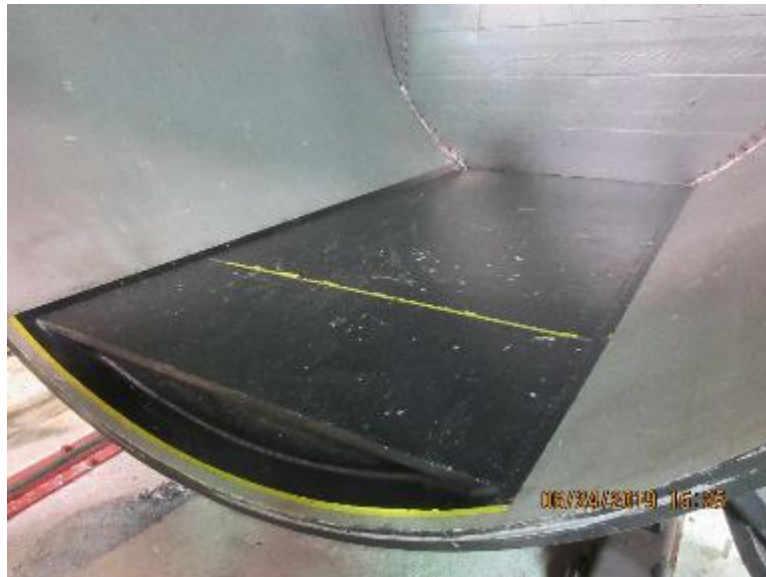
Photo No. 6
Post-test Specimen #2, Witness Chamber

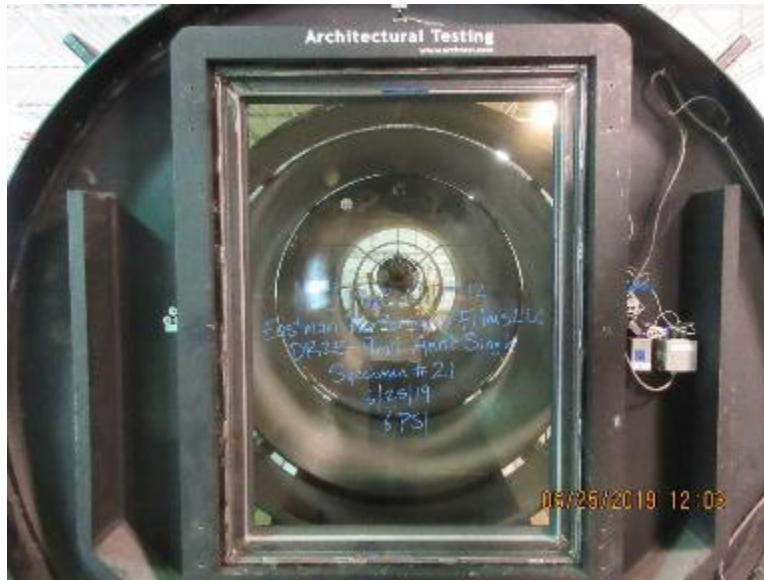
Photo No. 7
Pre-test Specimen #3, Interior

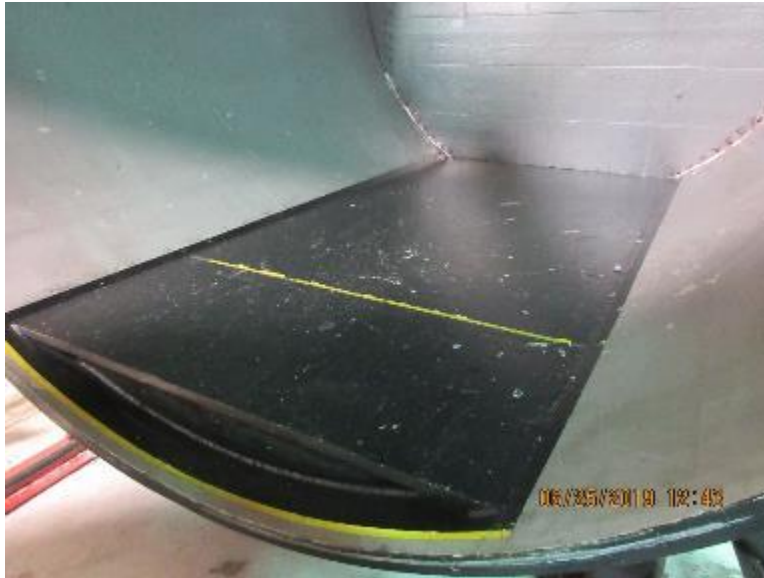
Photo No. 9
Post-test Specimen #3, Witness Chamber

DESCRIPTION	RESULTS
Ambient Temperature	84°F
Glazing Temperature	85°F
ASTM Hazard Rating	Low Hazard
GSA Performance Condition	3b
PEAK POSITIVE PRESSURE	
Top Pressure	6.33 psi
Right Pressure	6.05 psi
Shell Pressure	5.86 psi
Average Pressure	6.08 psi
Witness Chamber Pressure	0.21 psi
PEAK POSITIVE PHASE DURATION	
Top Duration	12.77 msec
Right Duration	11.42 msec
Shell Duration	12.59 msec
Average Duration	12.26 msec
PEAK POSITIVE PHASE IMPULSE	
Top Impulse	39 psi*msec
Right Impulse	39 psi*msec
Shell Impulse	38 psi*msec
Average Impulse	39 psi*msec
GLAZING RESPONSE	
Exterior Lite	Fractured
Interior Lite	N/A
Glazing Pullout	Bottom right corner interior
Film Tearing	None
WITNESS CHAMBER RESULTS	
Two indents found on the witness panel. Five fragments were found between the 1M mark and the 3M mark with a fragment total of 26.42g.
