AIRBLAST LOADING TEST REPORT

ASTM F1642/GSA TS01 TESTING ON *DR25 SR PS9* SAFETY AND SECURITY PERFORMANCE
FILM INSTALLED ON A FIXED WINDOW SYSTEM
(SINGLE PANE, TEMPERED, SILICONE GLAZING ATTACHMENT)

J3983.08-119-12 R0

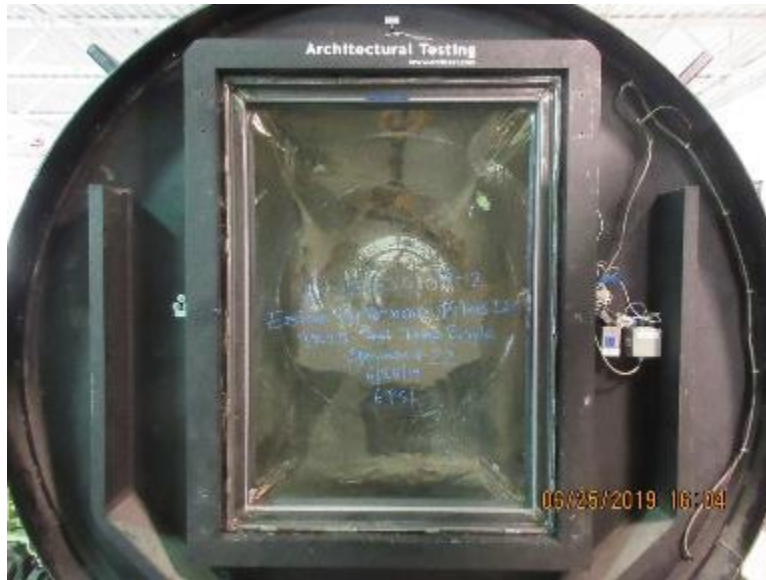
Photo No. 2
Post-test Specimen #1, Interior

DESCRIPTION	RESULTS
Ambient Temperature	86°F
Glazing Temperature	87°F
ASTM Hazard Rating	Minimal Hazard
GSA Performance Condition	3a
PEAK POSITIVE PRESSURE	
Top Pressure	6.29 psi
Right Pressure	6.33 psi
Shell Pressure	5.94 psi
Average Pressure	6.19 psi
Witness Chamber Pressure	0.40 psi
PEAK POSITIVE PHASE DURATION	
Top Duration	10.57 msec
Right Duration	11.93 msec
Shell Duration	13.23 msec
Average Duration	11.91 msec
PEAK POSITIVE PHASE IMPULSE	
Top Impulse	42 psi*msec
Right Impulse	42 psi*msec
Shell Impulse	42 psi*msec
Average Impulse	42 psi*msec
GLAZING RESPONSE	
Exterior Lite	Fractured
Interior Lite	N/A
Glazing Pullout	Bottom left corner interior
Film Tearing	None
WITNESS CHAMBER RESULTS	
A dusting of glass was deposited on the witness chamber floor. No fragments, on witness chamber floor and no indents or perforations on witness panel.

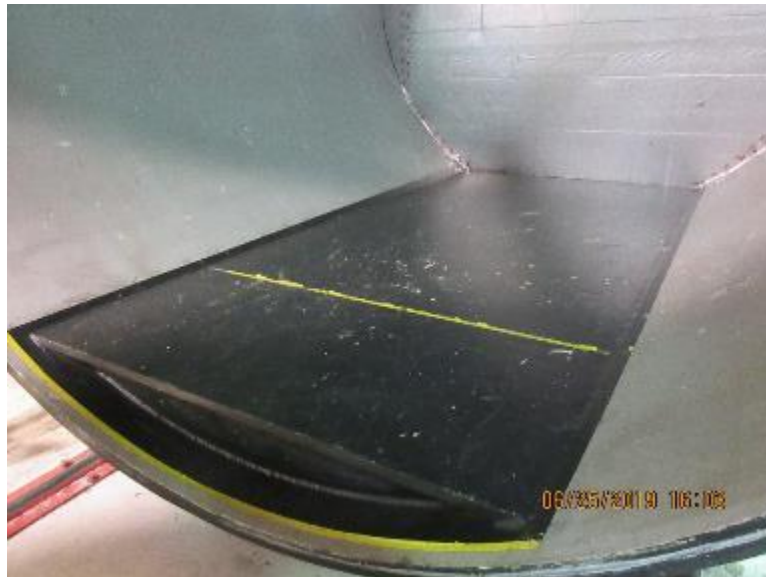
Photo No. 3
Post-test Specimen #1, Witness Chamber

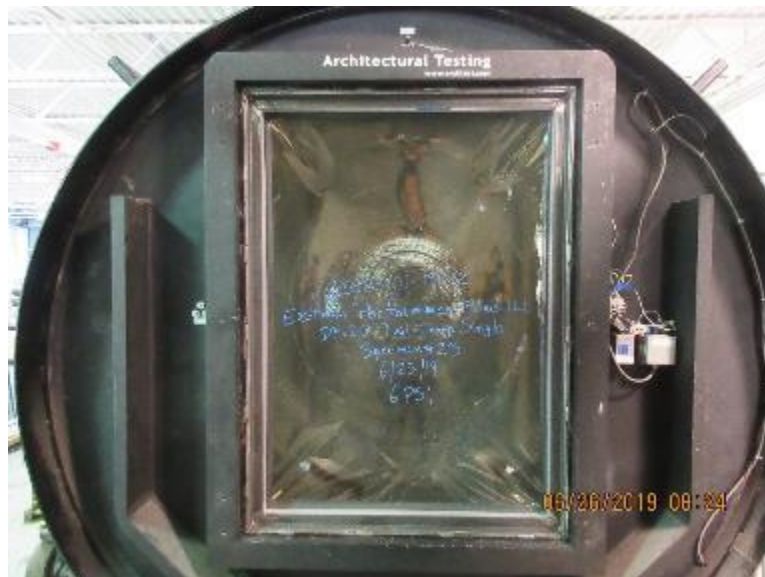
Photo No. 5
Post-test Specimen #2, Interior

DESCRIPTION	RESULTS
Ambient Temperature	87°F
Glazing Temperature	88°F
ASTM Hazard Rating	Minimal Hazard
GSA Performance Condition	3a
PEAK POSITIVE PRESSURE	
Top Pressure	6.25 psi
Right Pressure	6.50 psi
Shell Pressure	6.01 psi
Average Pressure	6.25 psi
Witness Chamber Pressure	0.35 psi
PEAK POSITIVE PHASE DURATION	
Top Duration	12.53 msec
Right Duration	10.84 msec
Shell Duration	12.99 msec
Average Duration	12.12 msec
PEAK POSITIVE PHASE IMPULSE	
Top Impulse	42 psi*msec
Right Impulse	42 psi*msec
Shell Impulse	41 psi*msec
Average Impulse	42 psi*msec
GLAZING RESPONSE	
Exterior Lite	Fractured
Interior Lite	N/A
Glazing Pullout	Bottom right corner interior
Film Tearing	None
WITNESS CHAMBER RESULTS	
A dusting of glass was deposited on the witness chamber floor.

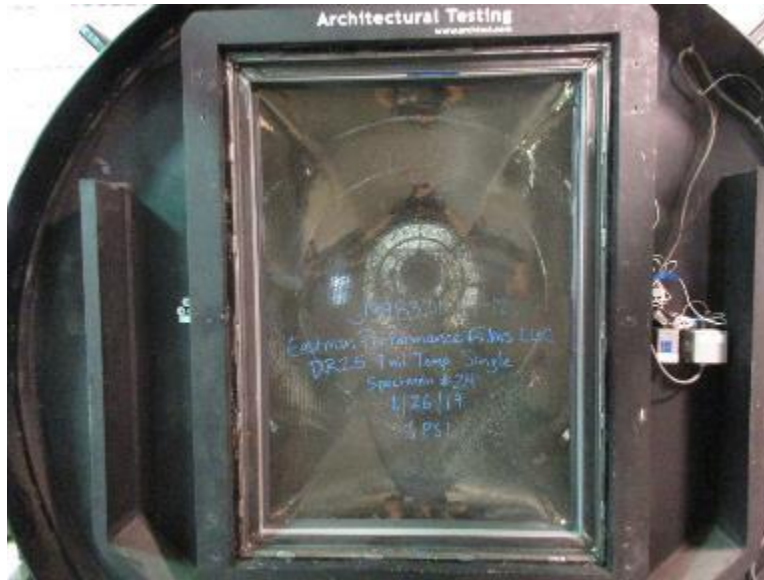
Photo No. 8
Post-test Specimen #3, Interior

DESCRIPTION	RESULTS
Ambient Temperature	82°F
Glazing Temperature	82°F
ASTM Hazard Rating	Minimal Hazard
GSA Performance Condition	3a
PEAK POSITIVE PRESSURE	
Top Pressure	6.13 psi
Right Pressure	6.34 psi
Shell Pressure	5.96 psi
Average Pressure	6.14 psi
Witness Chamber Pressure	0.34 psi
PEAK POSITIVE PHASE DURATION	
Top Duration	12.66 msec
Right Duration	11.93 msec
Shell Duration	13.12 msec
Average Duration	12.57 msec
PEAK POSITIVE PHASE IMPULSE	
Top Impulse	41 psi*msec
Right Impulse	41 psi*msec
Shell Impulse	41 psi*msec
Average Impulse	41 psi*msec
GLAZING RESPONSE	
Exterior Lite	Fractured
Interior Lite	N/A
Glazing Pullout	Top right corner interior
Film Tearing	None
WITNESS CHAMBER RESULTS	
A dusting of glass was deposited on the witness chamber floor.
